Stafsjö Sets New Benchmark for Maintenance-free KGVs at Recycled Paper Mill

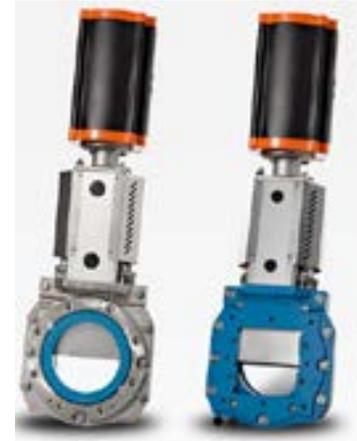
Staffsjö's RKO is reliable and particularly well suited for demanding reject and other abrasive media. The valve's circular inlet and square outlet, together with the gate, counteract clogging and blockages.

The Staffsjö RKO Knife Gate Valve (KGV) is specifically designed for the rigours of cyclone cleaner isolation and reject service. A rectangular outlet with blade guide strips prevents debris from becoming trapped in the valve. The bottom of the blade never fully retracts into the valve chest, leaving little to no chance of foreign objects being pulled into the packing area. This helps to eliminate jamming and maintain the valve's packing seal integrity.
