# Better Pump Protection at a Reduced Cost

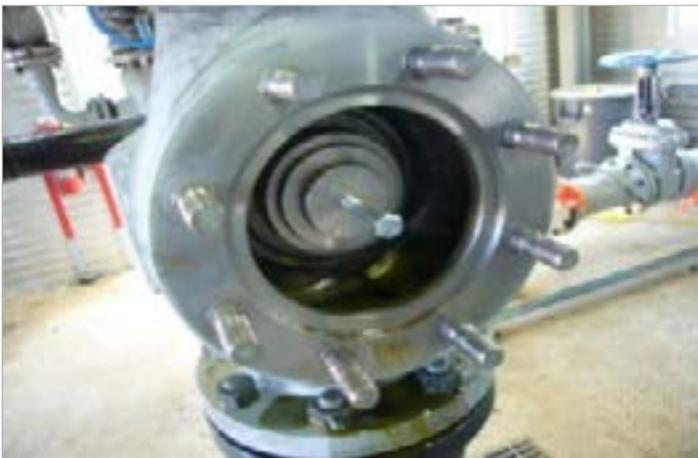
Fig 2. Top-entry, in-line serviceable

Unsatisfied with the frequent failure and costly servicing of their ARC valves, plant personnel actively sought an alternative and were introduced to the HORA ARC valve. HORA's top entry design enabled the valves to be opened and cleaned without removal from the line. Parts could be replaced in minutes by simply removing the bolted cover, removing the check valve insert assembly, installing replacement parts, and replacing the cover.

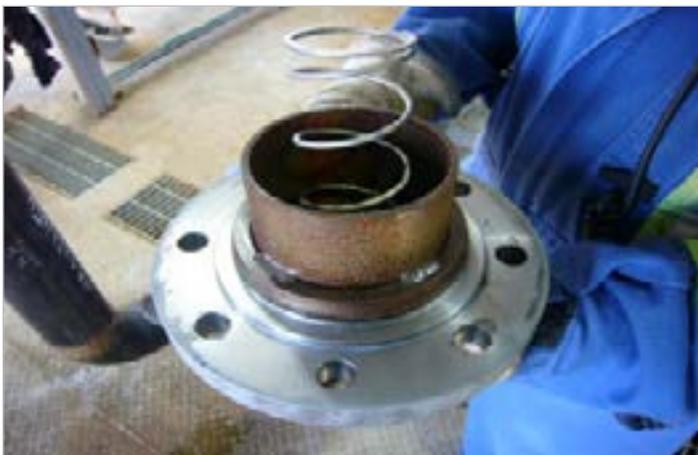
Fig 3. Check valve insert spring intact

Over a two-year trial period, maintenance personnel observed no pitting of body surfaces or disintegration of check valve insert springs on the HORA ARC valves. The valves proved themselves to be durable and offered

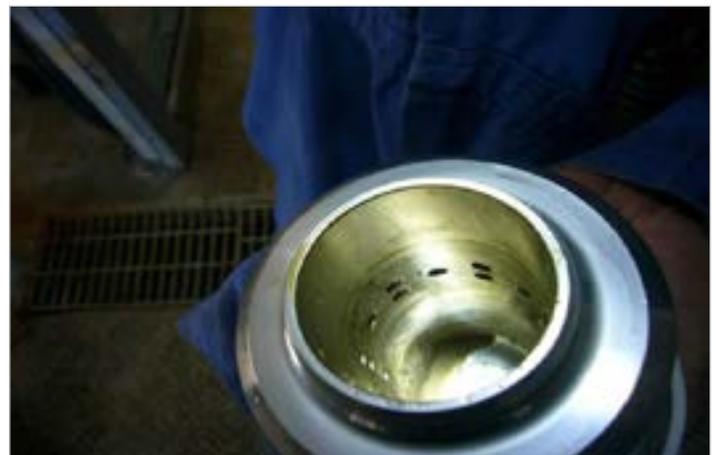
Fig 4. No evidence of body corrosion
